Mid Winooski River Watershed Phase 2 Stream Geomorphic Assessment & River Corridor Planning

Waterbury, Vermont

**Town of Waterbury
Phase 2 Stream Geomorphic Assessment Study Area**

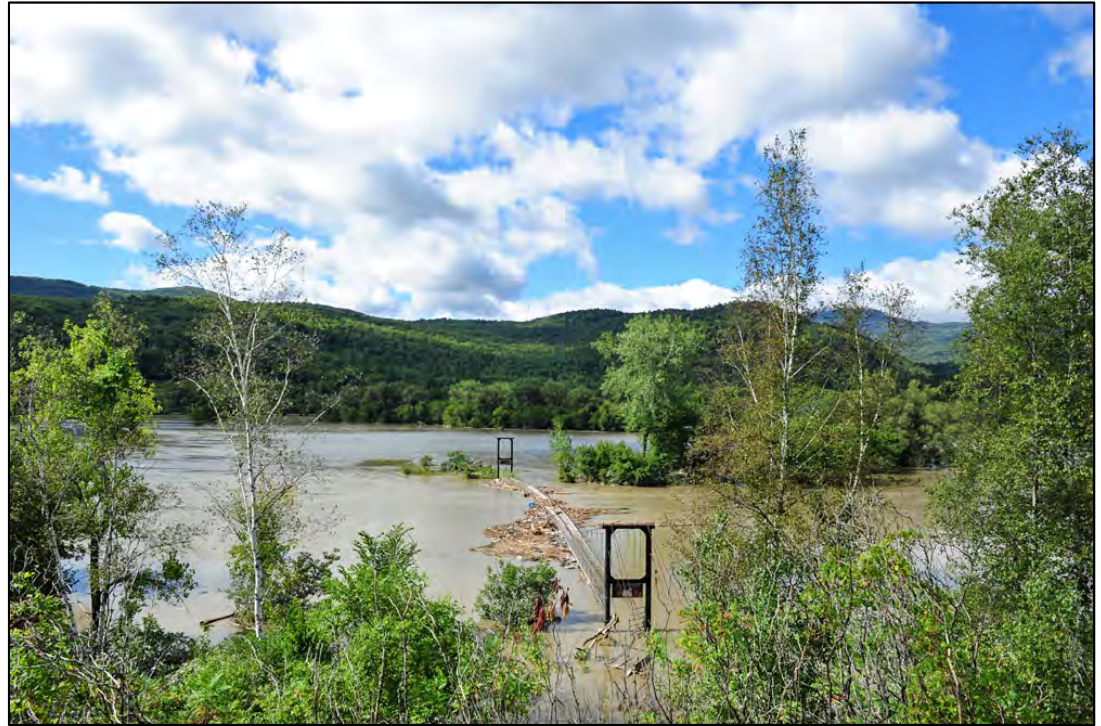
Photo of Winooski River following Irene from Mansfield Heliflight

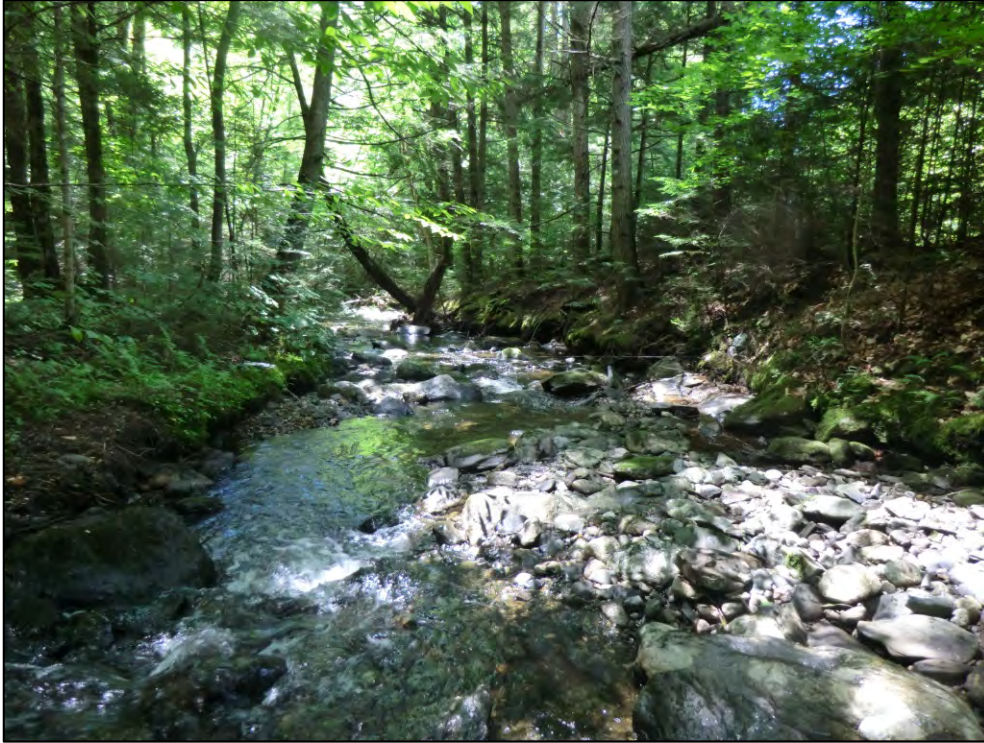
Geomorphically stable – Upper Thatcher Brook
R13.SI.02-SI.09-A

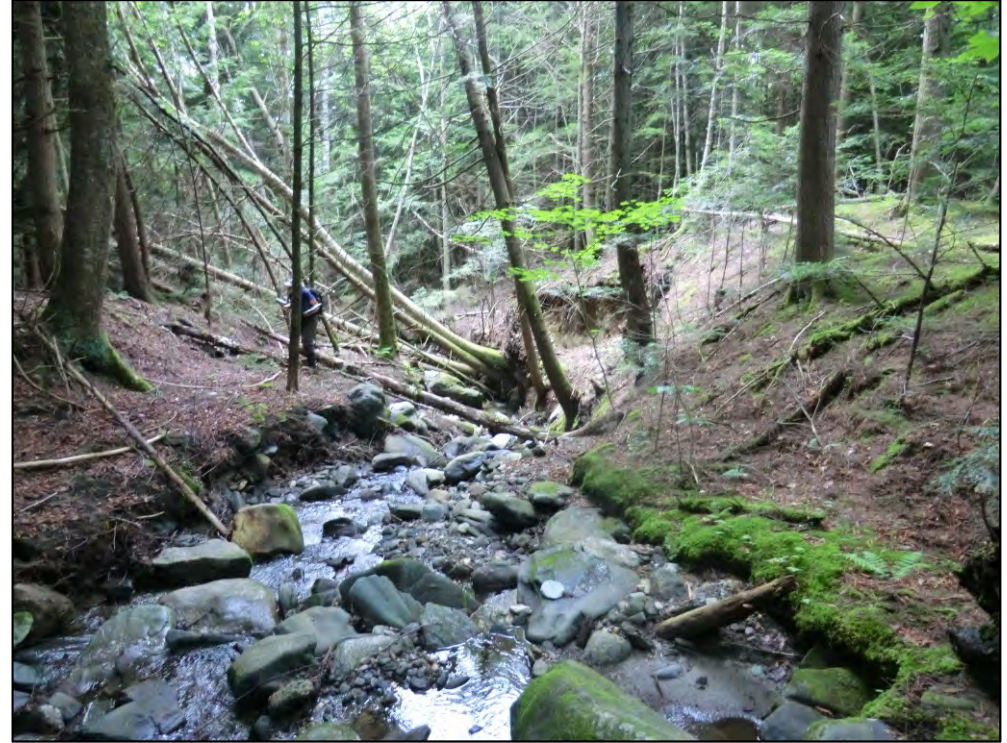
Geomorphically unstable – Upper Unnamed Tributary #2 to
Reach 3 of Thatcher Brook – R13.SI.02-SI.03-SI.02-C

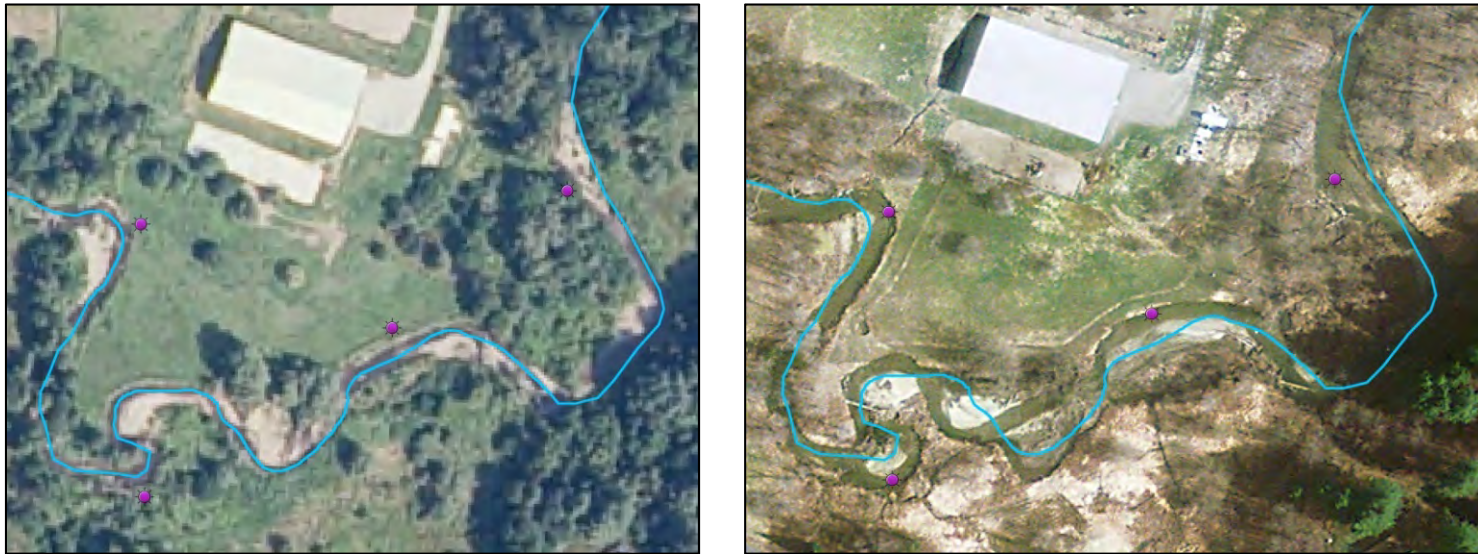
Figure 1. Side by side comparison of a location along Thatcher Brook where meander migration (purple dots) occurred likely as a result of TSI (2009 imagery on left, 2013 on right).

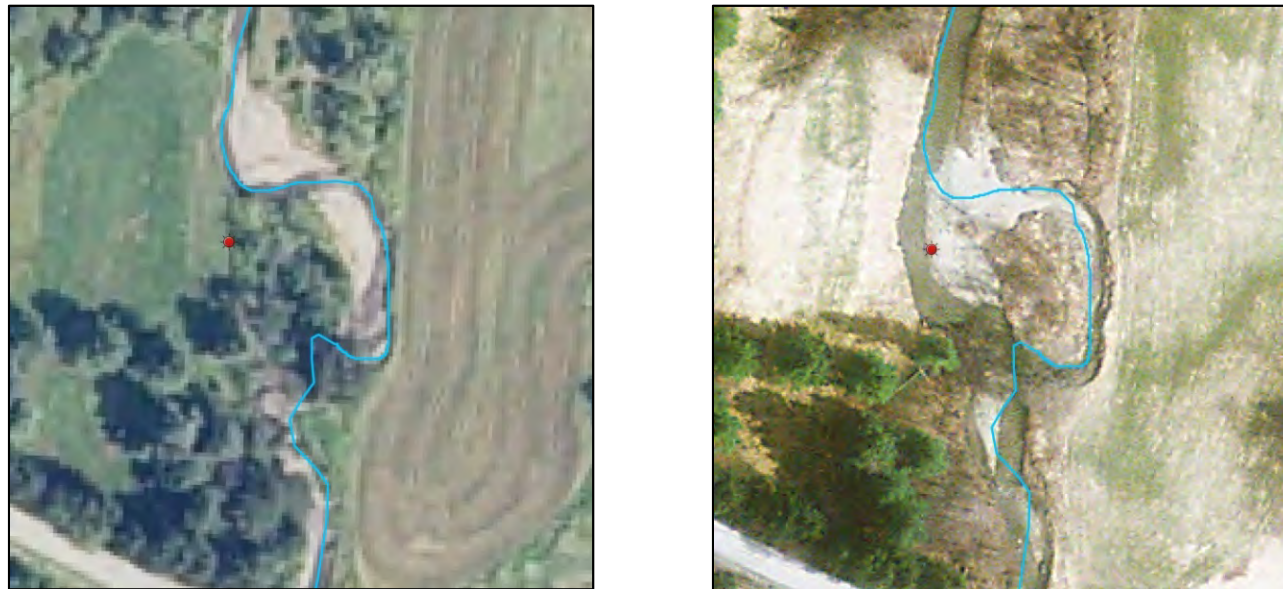
Figure 2. Side by side comparison of a location along Thatcher Brook where channel avulsion occurred as a result of TSI (2009 imagery on left, 2013 on right).
